SERVICE BULLETIN AMATEUR RADIO

SUBJECT	DATE
TS-940S SQUELCH SWITCHING NOISE	7-21-87

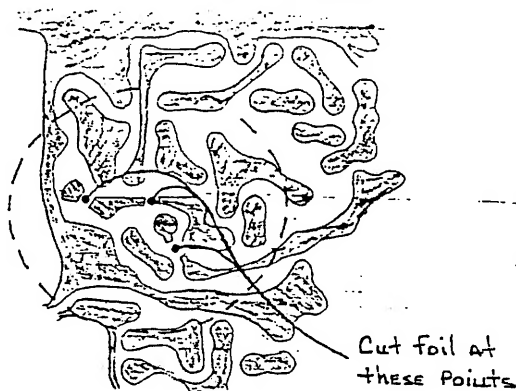
FIGURE 1

In some TS-940S below S/N 711xxxx, a "popping" or "clicking" noise may be heard when the squelch circuit is opened or closed. This may be more noticeable when an optional CW filter is installed. The following procedure will minimize the noise.

8. Using a small craft knife, cut the foil at the 3 points shown in figure 1 (top right corner of the board).
9. Unsolder and discard resistors R194 and R197. They are mounted on the component side of the board and soldered on the foil side.
